Construction of Improved Community Spring for Clean Drinking Water in Rural Peru

March 2, 2011

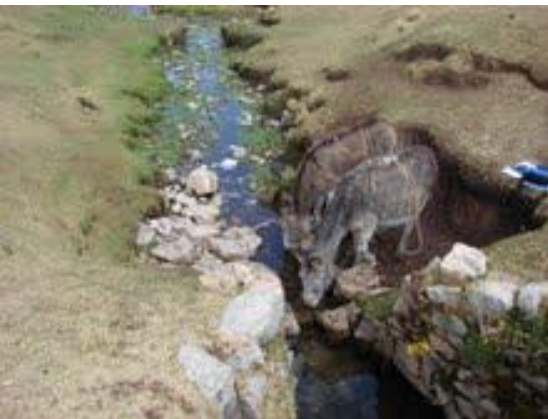
Figure 1: Community spring in Parina where community members get drinking water

The community of Parina primarily obtains their drinking water from unprotected springs contaminated by human and animal waste and unmaintained wells built by the government. The primary spring is a location in which the community obtains drinking and cooking water and takes their animals to drink (Figures 1 & 2). While water from this spring is initially pure and potable, environmental contamination and lack of maintenance leads to unclean drinking water in the spring. The structure of this spring is not ideal for preventing contamination of ground water and perpetuates water-related diseases. A local Peruvian non-governmental organization, Suma Marka, along with two dedicated community members have been conducting monthly water quality monitoring tests on the spring water since January 2010 and have consistently found bacterial contamination in the water. The spring has been seen to contain higher than normal levels of *Escherichia coli* and fecal coliforms. The presence of these indicator microbes increases the likelihood of gastrointestinal problems and diarrhea in Parina, especially among vulnerable children, pregnant women, and the elderly. Therefore, the construction of an improved community spring with a catchment box is needed to prevent further contamination of the spring and provide clean drinking water to Parina community.

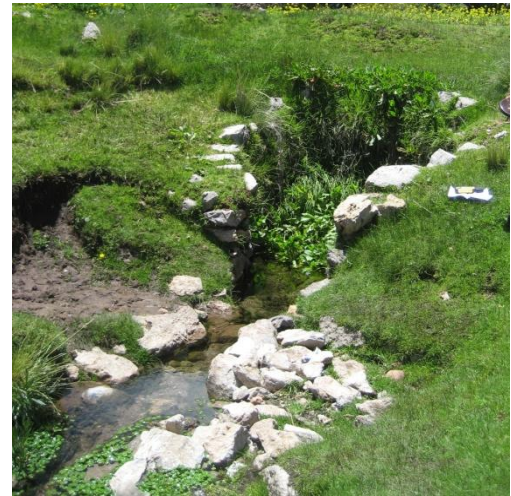
Figure 2: Parina community spring containing high concentrations of *E.coli* and fecal coliforms
